Manhole Inspection Summary

Manhole # S33E__047MH

Insp Date: **10/29/08 11:51 AM**

Location Address: **300 marion st**

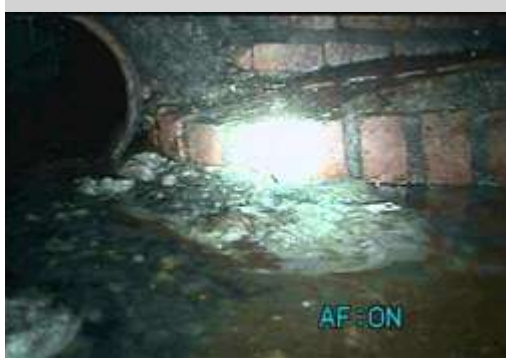
Defect 5

Condition: ☐ Sound ☐ Cracked ☐ Root Intrusion ☐ Deteriorated ☐ Leaks ☒ **Debris**

channel debris

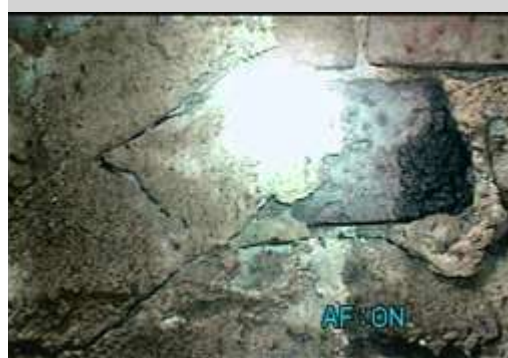
Defect 4

Condition: ☐ Sound ☒ **Cracked** ☐ Root Intrusion ☐ Loose Brick ☐ Deteriorated

cracked corbel

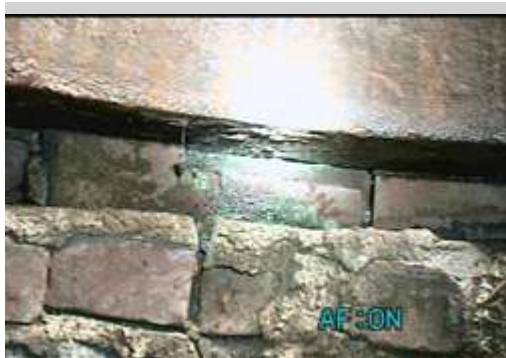
Defect 3

Condition: ☐ Sound ☒ **Cracked** ☐ Root Intrusion ☐ Loose Brick ☒ **Deteriorated**

cracked and deteriorated chimney, frame adj

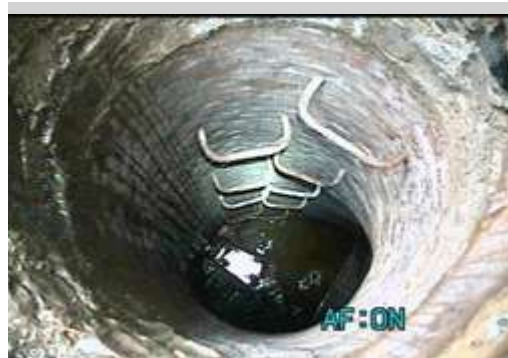
Defect 2

Count: **9** Missing: **0** ☒ **Corroded**

cor steps

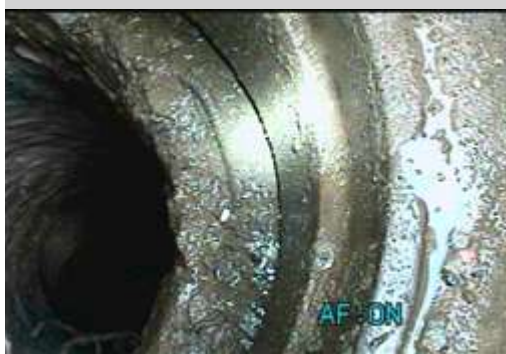
Defect 1

Offset: **4** (in.)

offset

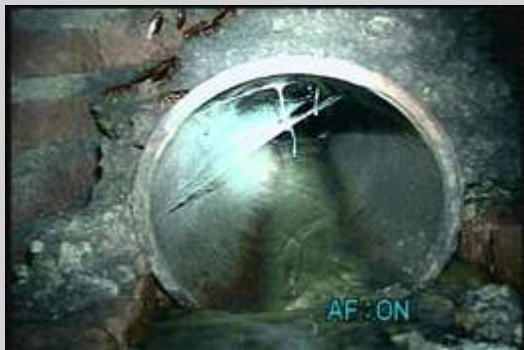
12 O'Clock Outflow

10 in. Circular Gravity Sewer
Pipe Out @ 12 O'Clock

Pipe Material: **Clay** ☐ Pipe Lined

Invert Depth: **15.50** (ft.) Flow Characteristics: **Fast**

Infiltration: **None** Pipe Seal Cond: **Unknown**

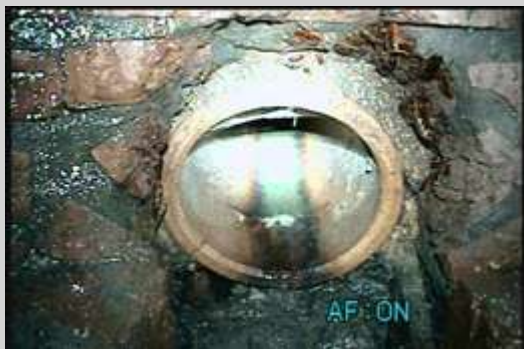
3 O'Clock Inflow

8 in. Circular Gravity Sewer
Pipe In @ 3 O'Clock

Pipe Material: **Clay** ☐ Pipe Lined

Invert Depth: **15.33** (ft.) Flow Characteristics: **Fast**

Infiltration: **None** Pipe Seal Cond: **Unknown**

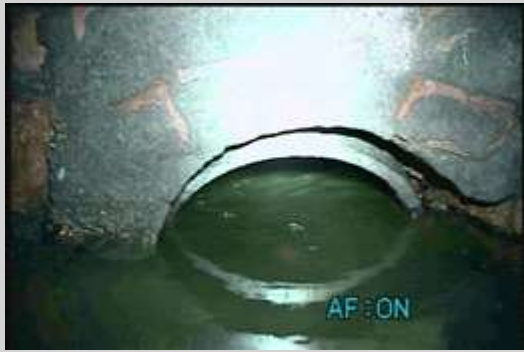
4 O'Clock Inflow

10 in. Circular Gravity Sewer
Pipe In @ 4 O'Clock

Pipe Material: **Clay** ☐ Pipe Lined

Invert Depth: **14.88** (ft.) Flow Characteristics: **Fast**

Infiltration: **None** Pipe Seal Cond: **Unknown**

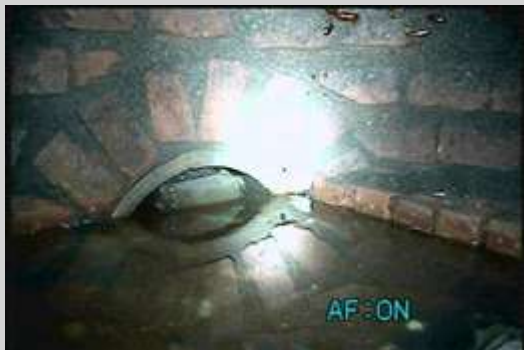
6 O'Clock Inflow

10 in. Circular Gravity Sewer
Pipe In @ 6 O'Clock

Pipe Material: **Clay** ☐ Pipe Lined

Invert Depth: **15.00** (ft.) Flow Characteristics: **None**

Connects To: **Stub connection / abandoned**
